ES_LPC3240

Errata sheet LPC3240

Rev. 9 — 1 June 2011

Errata sheet

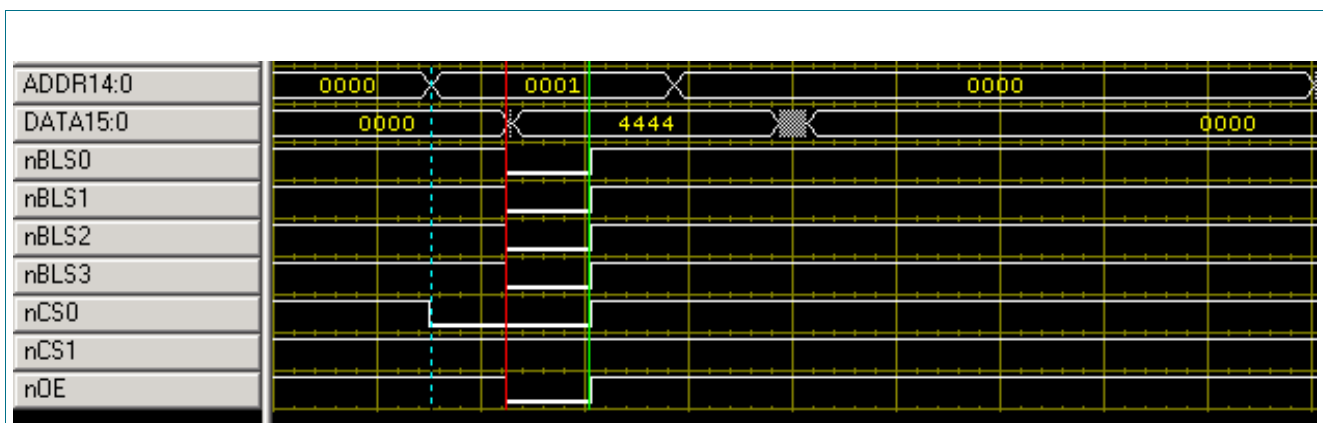
Fig 1. Scope shot 1 - expected read timing

When using memory-to-memory DMA with the EMC static chip select (EMC_CS[x]_N) as the DMA source and the DMA channel source burst size is set for a single transfer (DMACCxControl:SBSIZE = 0), each DMA source read should be a single bus-wide access. The access should be similar to reading the EMC_CS[x]_N static memory with an ARM LDR instruction, as shown in [Figure 1](#). Note the EMC signal timing for the read is controlled by the EMCSTATICx registers. In all example scope shots the EMCSTATICWAITx registers are set to the maximum value.

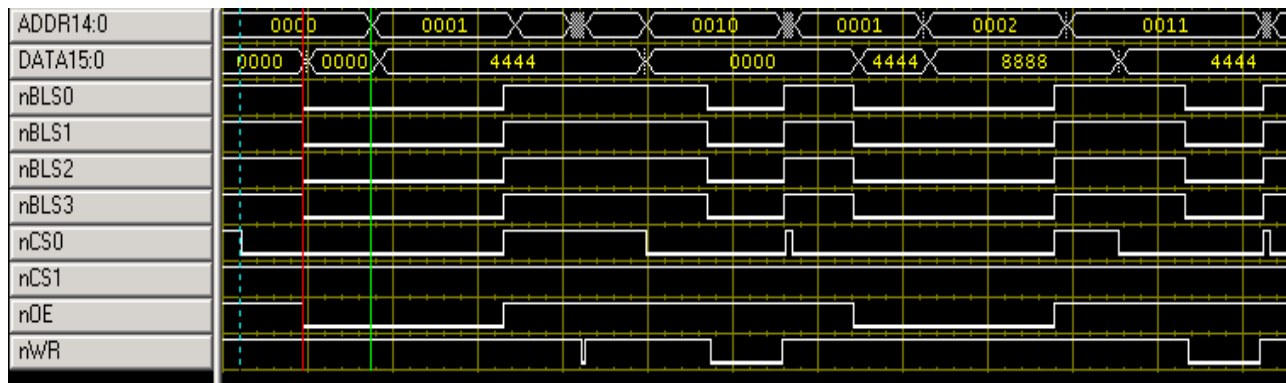
Fig 2. Scope shot 2 - actual read timing

However, the actual EMC timing for the source DMA read is a double wide chip select with a burst of two reads (notice how the address increments near the halfway point of nCS0 active), see [Figure 2](#). The second data read during the burst is discarded, as the DMA destination write (also to nCS0 in [Figure 2](#)) following each read, always writes the first value read during the read burst. When the DMA source address is set to auto-increment, the last DMA read transfer will address the last address of the source buffer and the last source buffer address +1. This behavior only happens during the read part of the DMA transfer. Memory-to-memory DMA destination writes to the EMC static chip select work as expected.

1. DMA reads from an external memory will have lower performance than a software read loop. The source read burst of two, to get one transfer, will significantly increase the time to complete all transfers in the memory-to-memory DMA, therefore decreasing the overall throughput possible on the EMC_CSx_N static memory interface.
2. Potential unintended consequence when the last DMA read accesses the address beyond the DMA source buffer address in the FPGA or external peripheral chip. This extra address is the second access during the last DMA source read.

1. Avoid using DMA to transfer read blocks of data from the external device. Instead use a software loop with LDR instruction to read blocks of data from the external device.
2. If DMA can't be avoided, ensure there is at least one unused address between the highest address used for the external device DMA data buffer and any status or control register in the device that will initiate any unwanted action just by reading from the register (i.e. clear an interrupt or status).

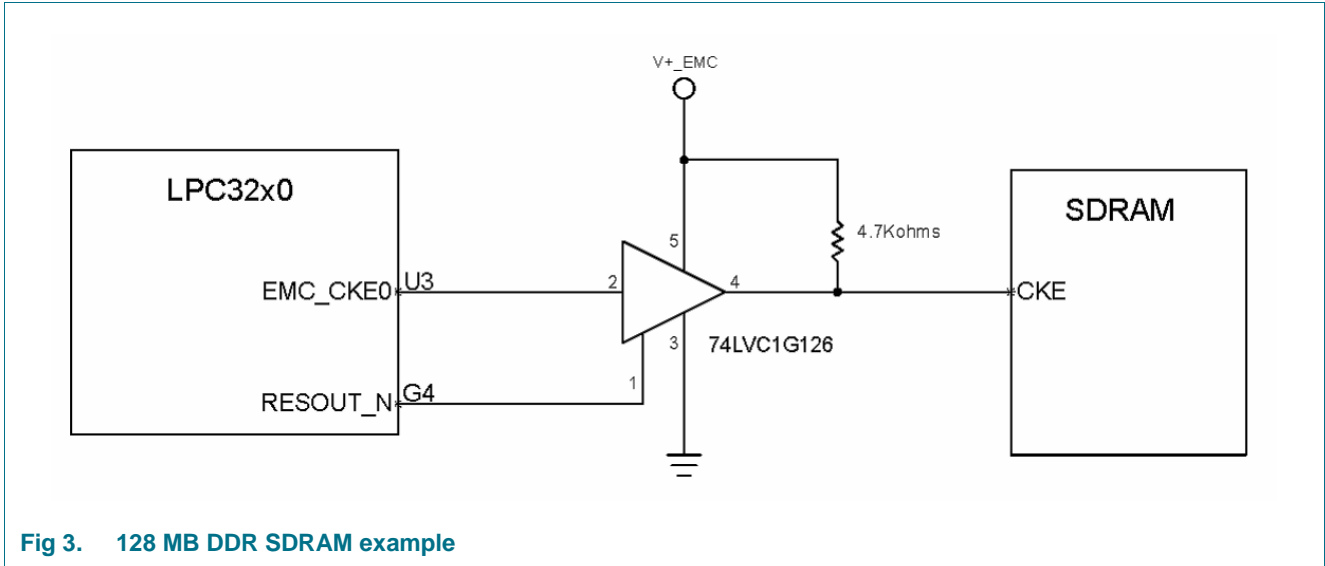
Fig 3. 128 MB DDR SDRAM example

If the LPC3240 is reset during an SDRAM access, the SDRAM clock and clock enable will be immediately de-asserted. If the de-assertion occurs during the period of time the SDRAM is driving the data bus, the SDRAM will hold that state until the next clock occurs at the SDRAM clock input when the clock enable is active. However, the LPC3240 won't deliver the clock and clock enables until software actually sets up the EMC state to do this, so the SDRAM will remain in the data assertion state on the data bus while the LPC3240 tries to boot.

When the chip attempts to load boot code from NOR FLASH after reset, the correct signals are asserted to the NOR FLASH device and the NOR FLASH device places its data on the data bus. But if the SDRAM is still driving the bus, the NOR FLASH device and SDRAM device are in contention and the data will not be read correctly into the LPC3240. In this situation, the LPC3240 will fail to boot.

If booting from NOR FLASH is a requirement, the simple circuit shown in [Figure 3](#) can be used to clear the SDRAM state at system reset. This will not change the normal functioning of the LPC3240 EMC or SDRAM operations. If SDRAM devices are also present on the 2nd SDRAM chip select, a similar circuit will be needed for those devices using EMC_CKE1.

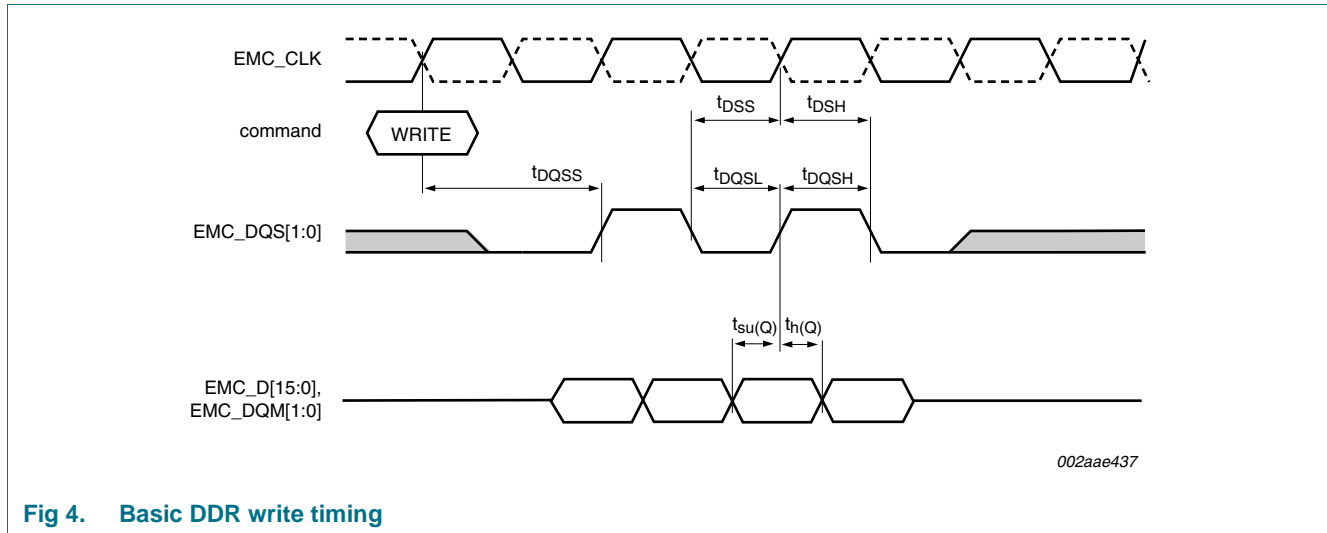
Fig 4. Basic DDR write timing

For DDR writes the LPC3240 drives the EMC_DQS[1:0] earlier in the data valid window than center aligned. With the EMC_CLK at 133 MHz this produces a minimum set-up time between the EMC_D[15:0] and EMC_DQS[1:0] of 600 ps across silicon process, voltage and temperature. Test conditions are with the EMC buffers set to fast slew rate driving 2 inches of 50 Ω transmission line and 10 pF load capacitance. DDR memories specify EMC_D[15:0] to EMC_DQS[1:0] set-up time minimum as 400 ps. This leaves 200 ps set-up time margin due to customer specific load and PCB layout implementation. See the LPC3220_30_40_50 data sheet for the complete range of DDR data output set-up time, $t_{su(Q)}$, and data output hold time $t_{h(Q)}$ times.
