Device Errata

Skywire™ Modem

NimbeLink // Products
Published // June, 2015

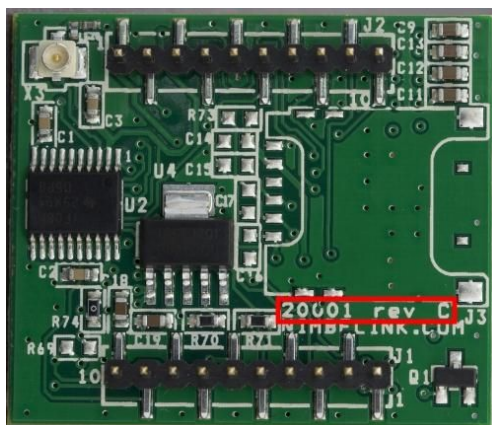
The PCB revision is found on the bottom side of the modem between J1 (XBEE interface connector) and J3 (Micro-SIM socket). The revision is written in white silkscreen and is of the form 20001 rev X.

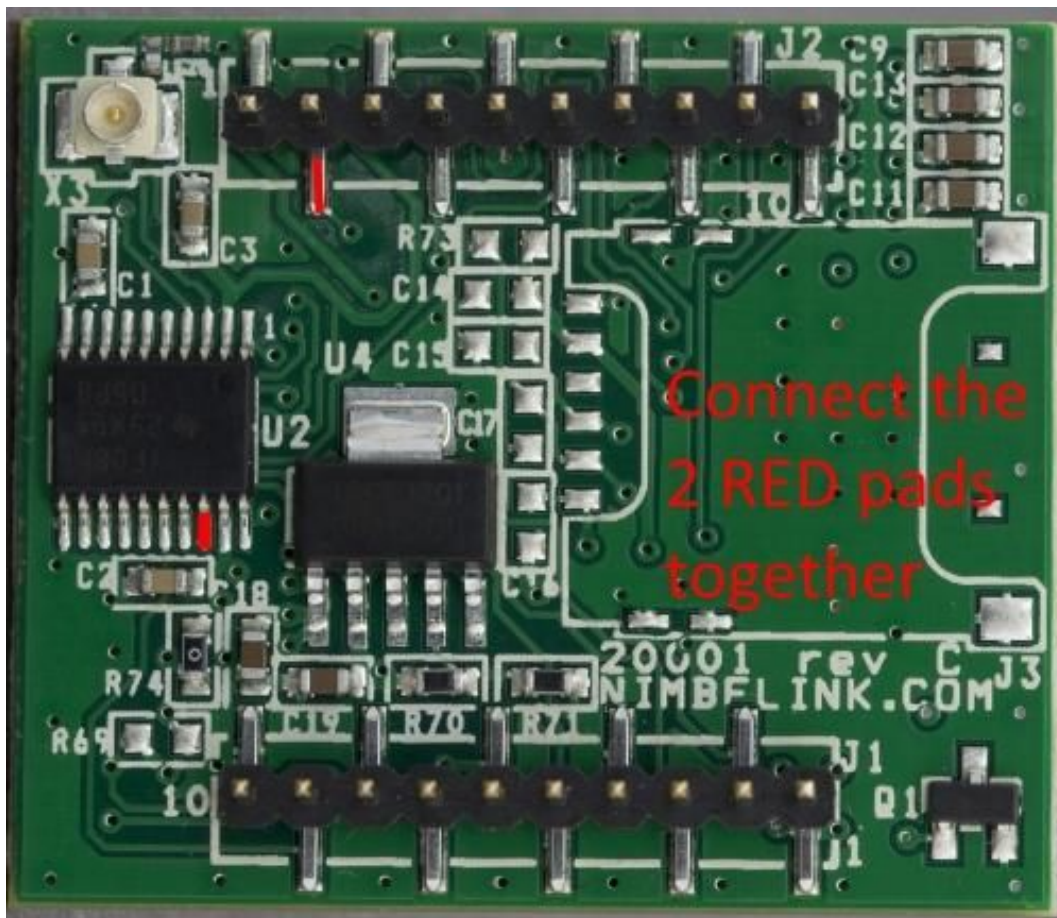
This Errata affects applications requiring use of the UART CTS hardware flow control output from the Skywire™ modem. The UART CTS signal (Pin 12 on the XBEE interface) is not connected on NimbeLink PCBs prior to PCB revision F. This Errata does not affect your design if any of the following are true:

The Errata can be repaired on affected product by soldering a wire to the underside of the modem. The wire must connect XBEE interface pin 12 to U2 pin 18. Adding this wire will not invalidate the product warranty, however, poor workmanship can damage the modem and invalidate the warranty.
