## PIC24FJ256GB210 Family Silicon Errata and Data Sheet Clarification

The PIC24FJ256GB210 family devices that you have received conform functionally to the current Device Data Sheet (DS39975A), except for the anomalies described in this document.

The errata described in this document will be addressed in future revisions of the PIC24FJ256GB210 family silicon.

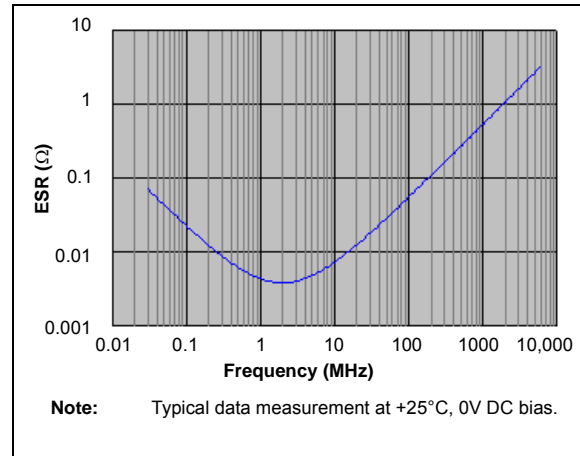
**FIGURE 2-3 FREQUENCY vs. ESR PERFORMANCE FOR SUGGESTED VCAP**

When the regulator is enabled, a low-ESR ( $< 5\Omega$ ) capacitor is required on the VCAP pin to stabilize the voltage regulator output voltage. The VCAP pin must not be connected to VDD and must use a capacitor of 10  $\mu\text{F}$  connected to ground. The type can be ceramic or tantalum. Suitable examples of capacitors are shown in [Table 2-1](#). Capacitors with equivalent specifications can be used.

Designers may use [Figure 2-3](#) to evaluate ESR equivalence of candidate devices.

The placement of this capacitor should be close to VCAP. It is recommended that the trace length not exceed 0.25 inch (6 mm). Refer to **Section 29.0 “Electrical Characteristics”** for additional information.

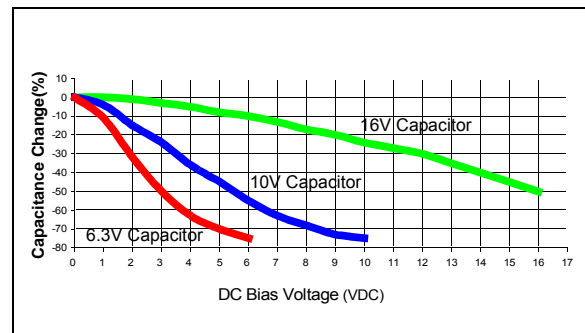
**FIGURE 2-4 DC BIAS VOLTAGE vs. CAPACITANCE CHARACTERISTICS**

In addition to temperature tolerance, the effective capacitance of large value ceramic capacitors can vary substantially, based on the amount of DC voltage applied to the capacitor. This effect can be very significant, but is often overlooked or is not always documented.

A typical DC bias voltage vs. capacitance graph for 16V, 10V and 6.3V rated capacitors is shown in Figure 2-4.

When selecting a ceramic capacitor to be used with the internal voltage regulator, it is suggested to select a high-voltage rating, so that the operating voltage is a small percentage of the maximum rated capacitor voltage. For example, choose a ceramic capacitor rated at 16V for the 1.8V core voltage. Suggested capacitors are shown in Table 2-1.

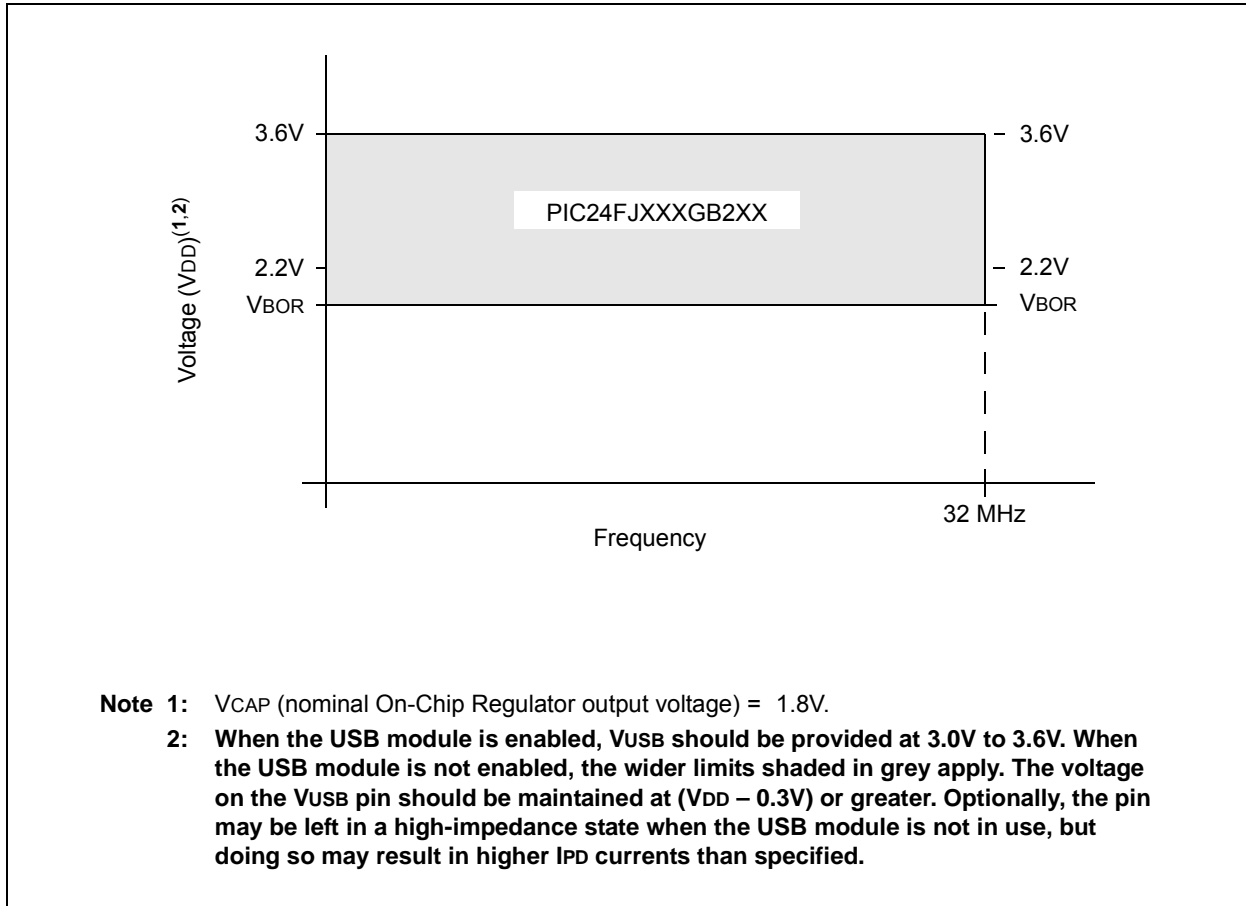
**FIGURE 29-1: PIC24FJ256GB210 FAMILY VOLTAGE-FREQUENCY GRAPH (INDUSTRIAL)**

Figure 29-1 (“PIC24FJ256GB210 Family Voltage-Frequency Graph”) is amended by adding an additional footnote. The updated figure is shown below (changes in **bold**; bold in original removed for clarity).
